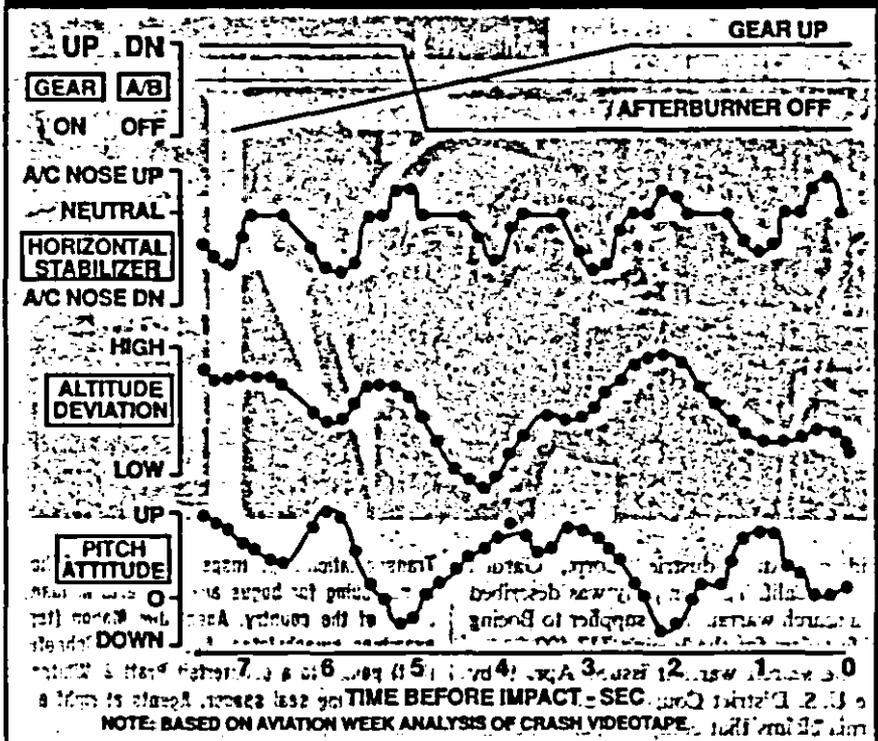
## YF-22A CRASH

structure was destroyed by the fire. The test data recorders in the nose survived and telemetry was being recorded as well, giving investigators information to help determine the cause of the accident.

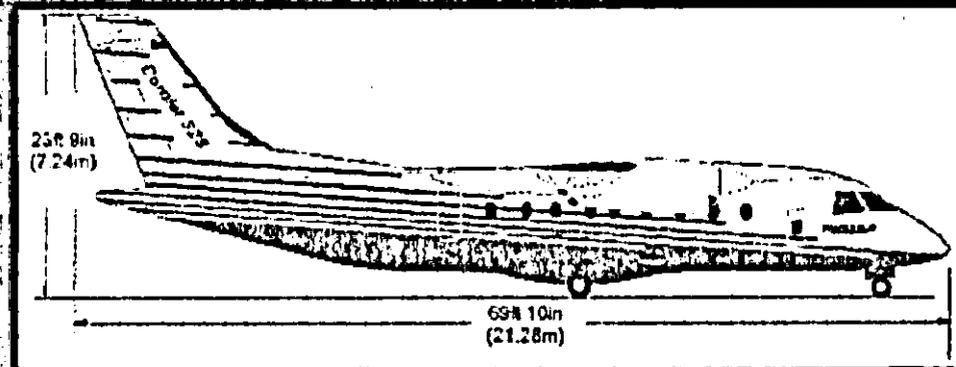
- It was flight #101 of the Dornier 328-100 prototype aeroplane TAC 1 operated under the experimental flight permit under the registration D-CHIC.
- The test program asked for sideslip testing in all 4 configurations at several speeds and power settings. The critical test point #14 was run after #15 in the same configuration but 95% torque instead of idle power.
- The test procedure asked for slow increase of sideslip and slow rudder release on recovery.
- The test were performed as wings level sideslips.

- By actuating the rudder to the left, with a pedal force of 35 daN (77 lbs), full rudder deflection of 22 degrees was achieved at a yaw angle of 20.5 degrees.
- During the build up of sideslip it was necessary to pull more and more elevator to counteract the increasing nose down moment. Maximum pull force was 20 daN (44 lbs).
- Briefly before reaching full rudder deflection, the aeroplane started buffeting. The stick was slightly released and the nose dropped significantly.
- During this time the required rudder forces decreased from 35 to 25 daN. Gradient reversal with positive force.

- Although sideslip tests have been performed with the propeller for its initial certification on a test bed aeroplane, on these tests the propeller is experiencing generic sideslip conditions, lacking the flow distortion caused by the fuselage when installed on the wing of the Dornier 328 aeroplane.
- THIS CONTINUOUS BENDING MOTION DURING EACH REVOLUTION HAD NOT BEEN CONSIDERED.
- In retrospective the fatigue life for this condition was estimated to be far less than one hour total.
- The propeller root was structurally reinforced for the serial propeller certificated with the aeroplane.

- Rudder limit introduced.
  - Wing-Fuselage fairing redefined.
  - Ventral Fins added.
  - Vortex flow generators introduced on the vertical fin to improve stabiliser and elevator airflow flow.
  - Landing Flap setting reduced to 20 degrees.
- 
- Redefined larger ventral fins.
  - Roll Spoilers added.
  - REDS, Rudder Expanded Deflection System

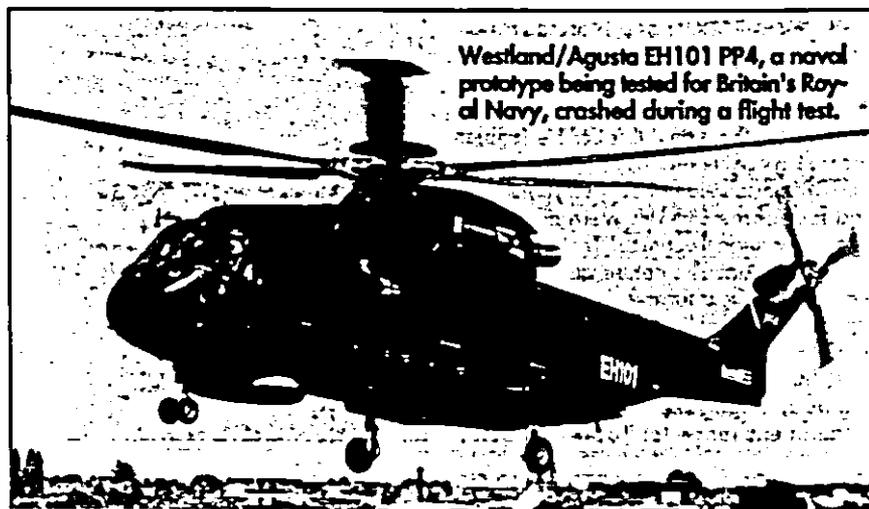
Westland/Agusta EH101 PP4, a naval prototype being tested for Britain's Royal Navy, crashed during a flight test.
