BAC 1-11

"Deep Stall"

British Ministry of Aviation Accident Report:

Stable Stall Ruled BAC 111 Crash Cause

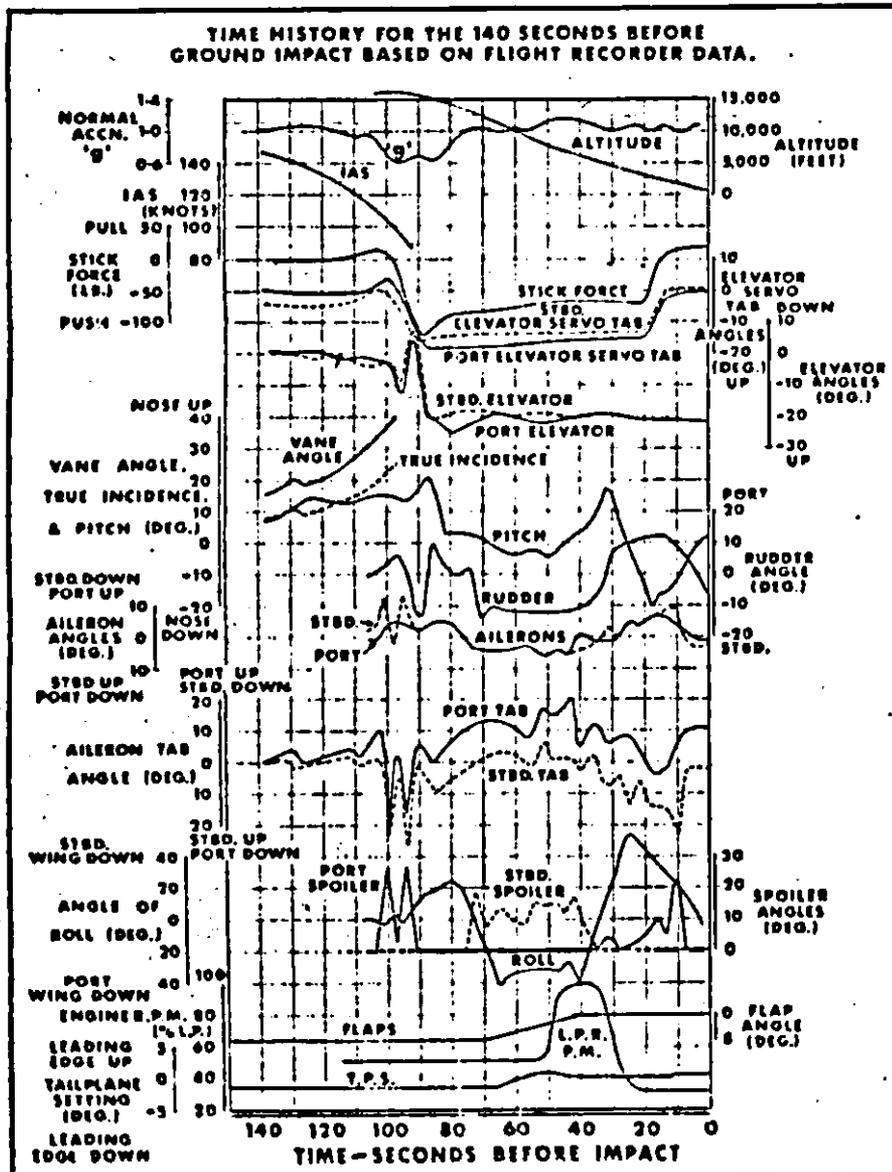
DATA GATHERED FROM two recorders, a Royston Instruments Midas and a Colbrook Instruments O2E, give time-history of last 140 sec. of flight of BAC 111 that crashed.

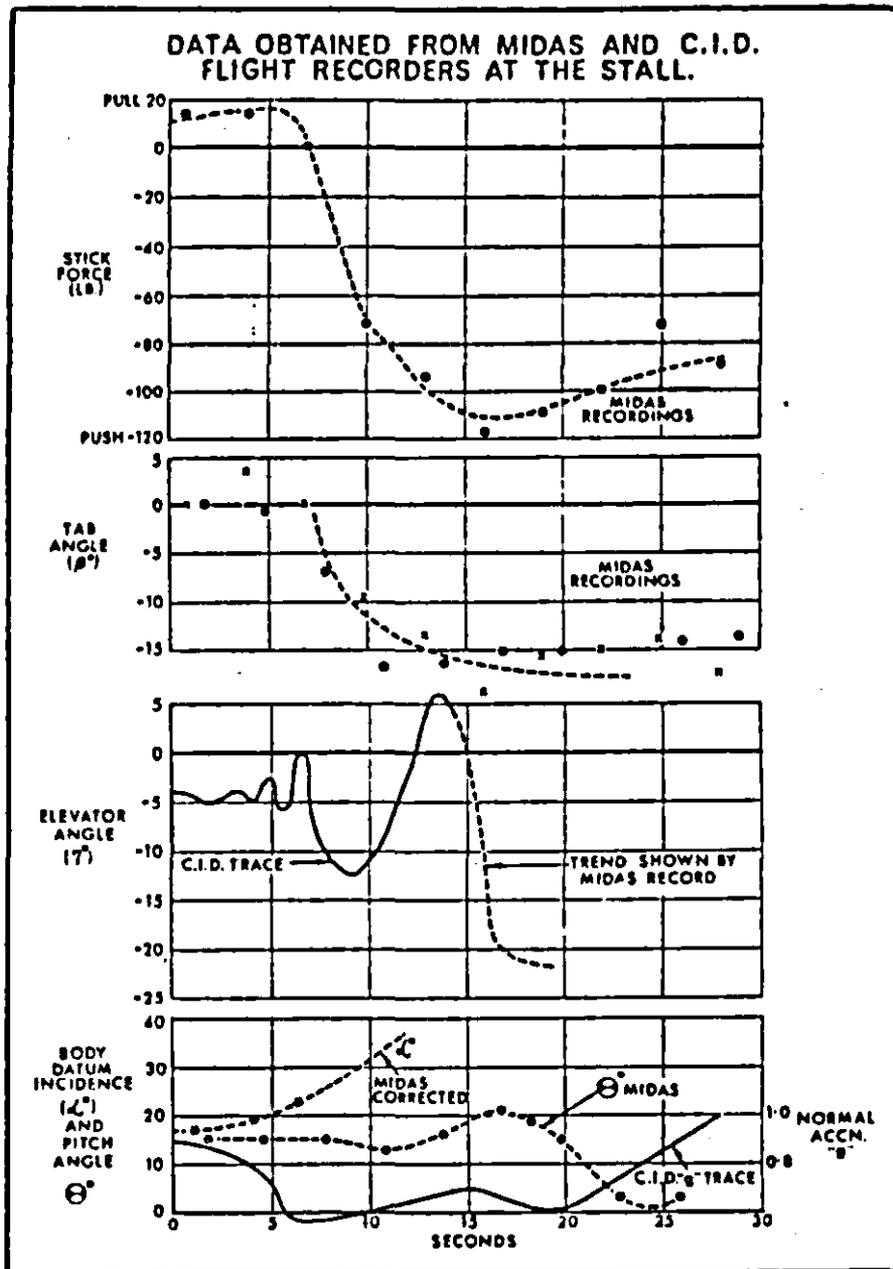
FLIGHT RECORDER DATA charted above shows pilot's attempt to recover from stable stall. Period shown occurred between 110 and 80 sec. before aircraft crashed.

Whilst there is some lack of evidence on the pilot's intentions in this stalling test, the traces, taken in conjunction with Mr. Lithgow's remark after the previous stalling tests that it should be possible to fight one's way through the wing drop, are not inconsistent with an attempt to reach a stall as defined by the British Civil Airworthiness Requirements. As a result, the aircraft penetrated further into the post-stall region than it had been taken previously and reached the stable stalled condition from which recovery was not possible.

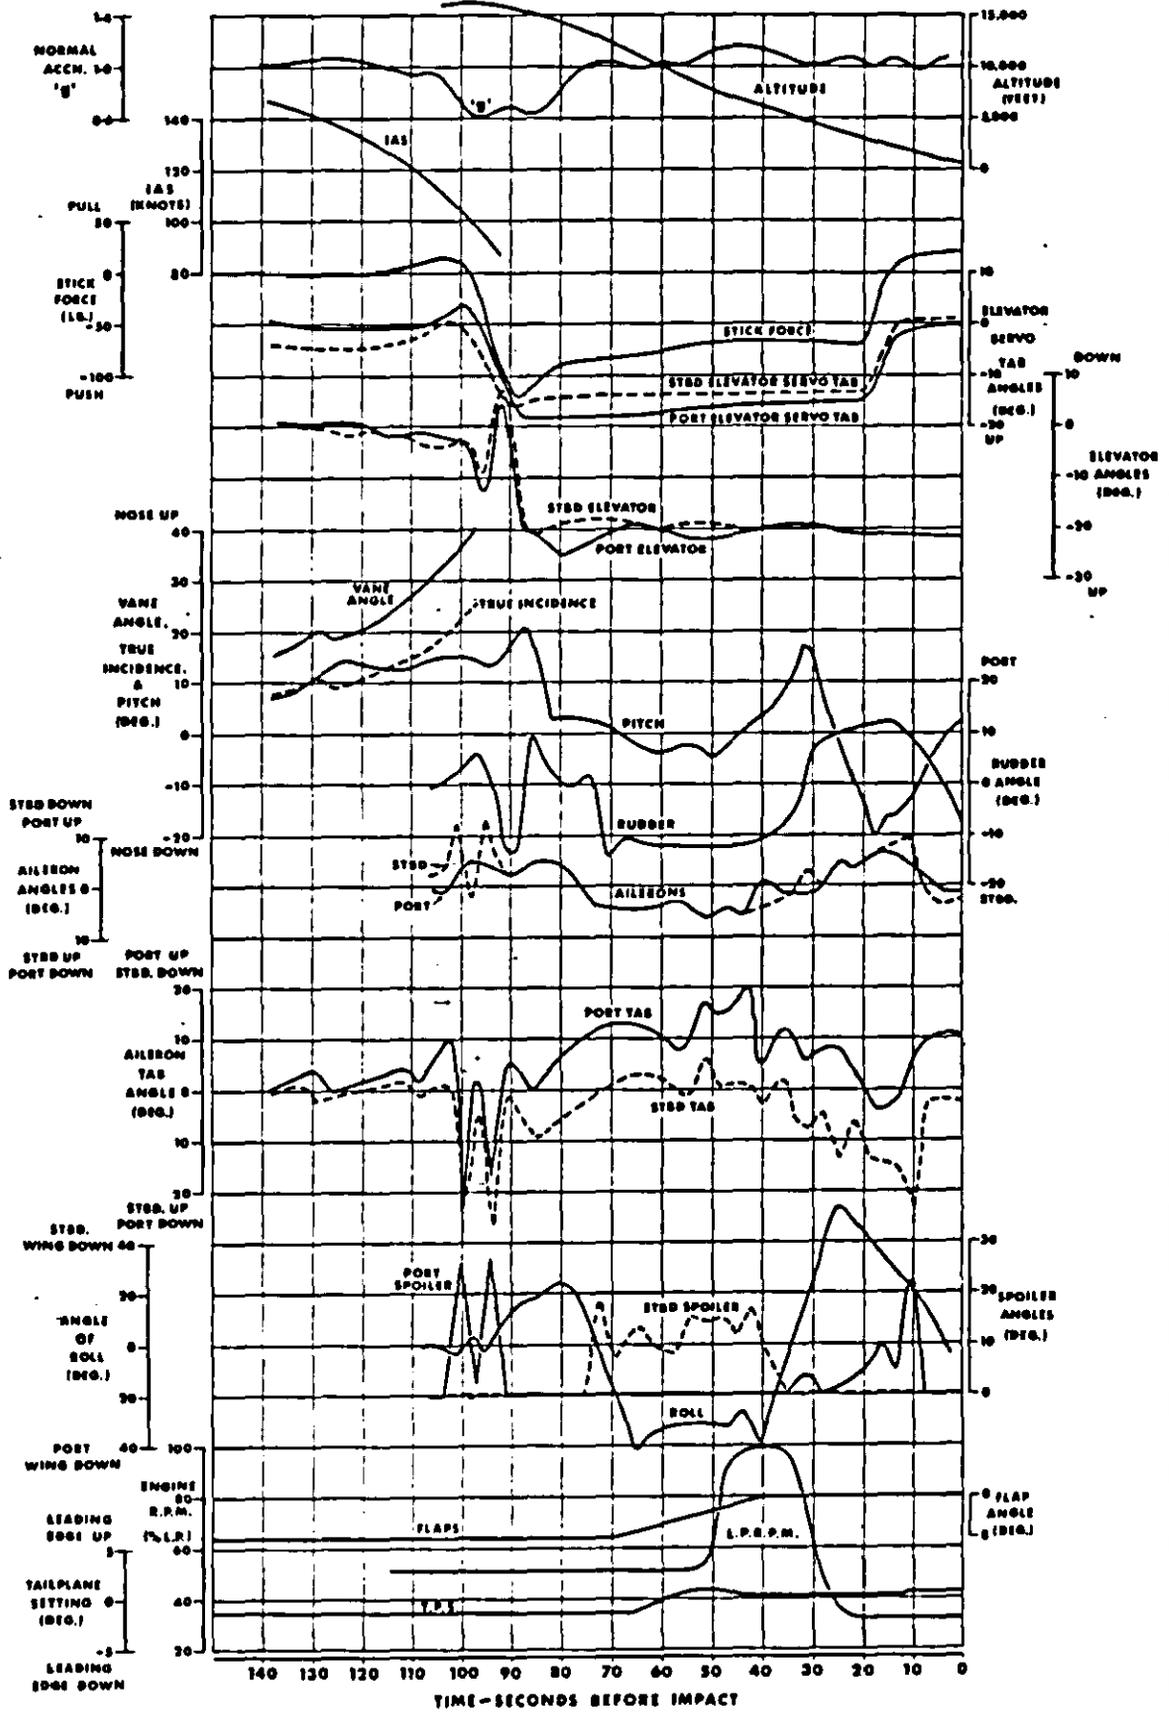
APPENDIX 'A'

TIME HISTORY FOR THE 140 SECONDS BEFORE GROUND IMPACT BASED ON FLIGHT RECORDER DATA.

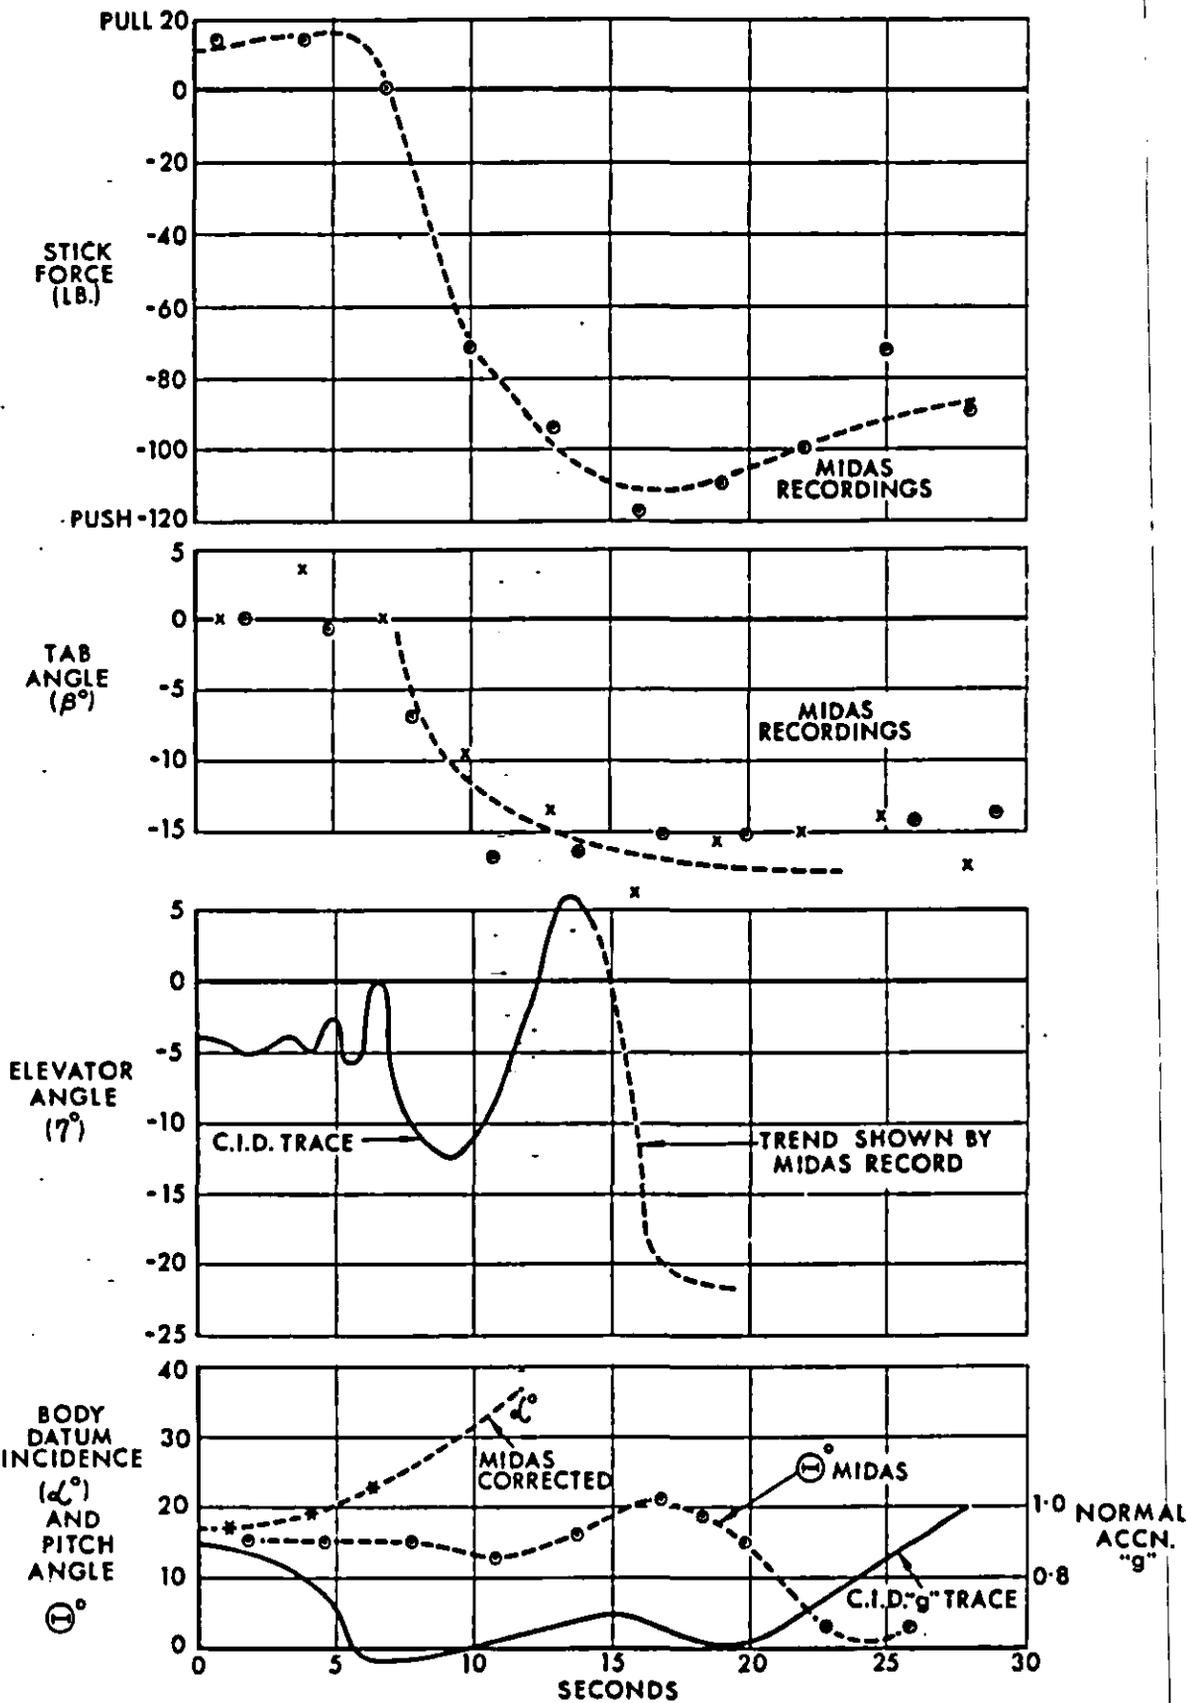
Appendix "B"

DATA OBTAINED FROM MIDAS AND C.I.D. FLIGHT RECORDERS AT THE STALL.

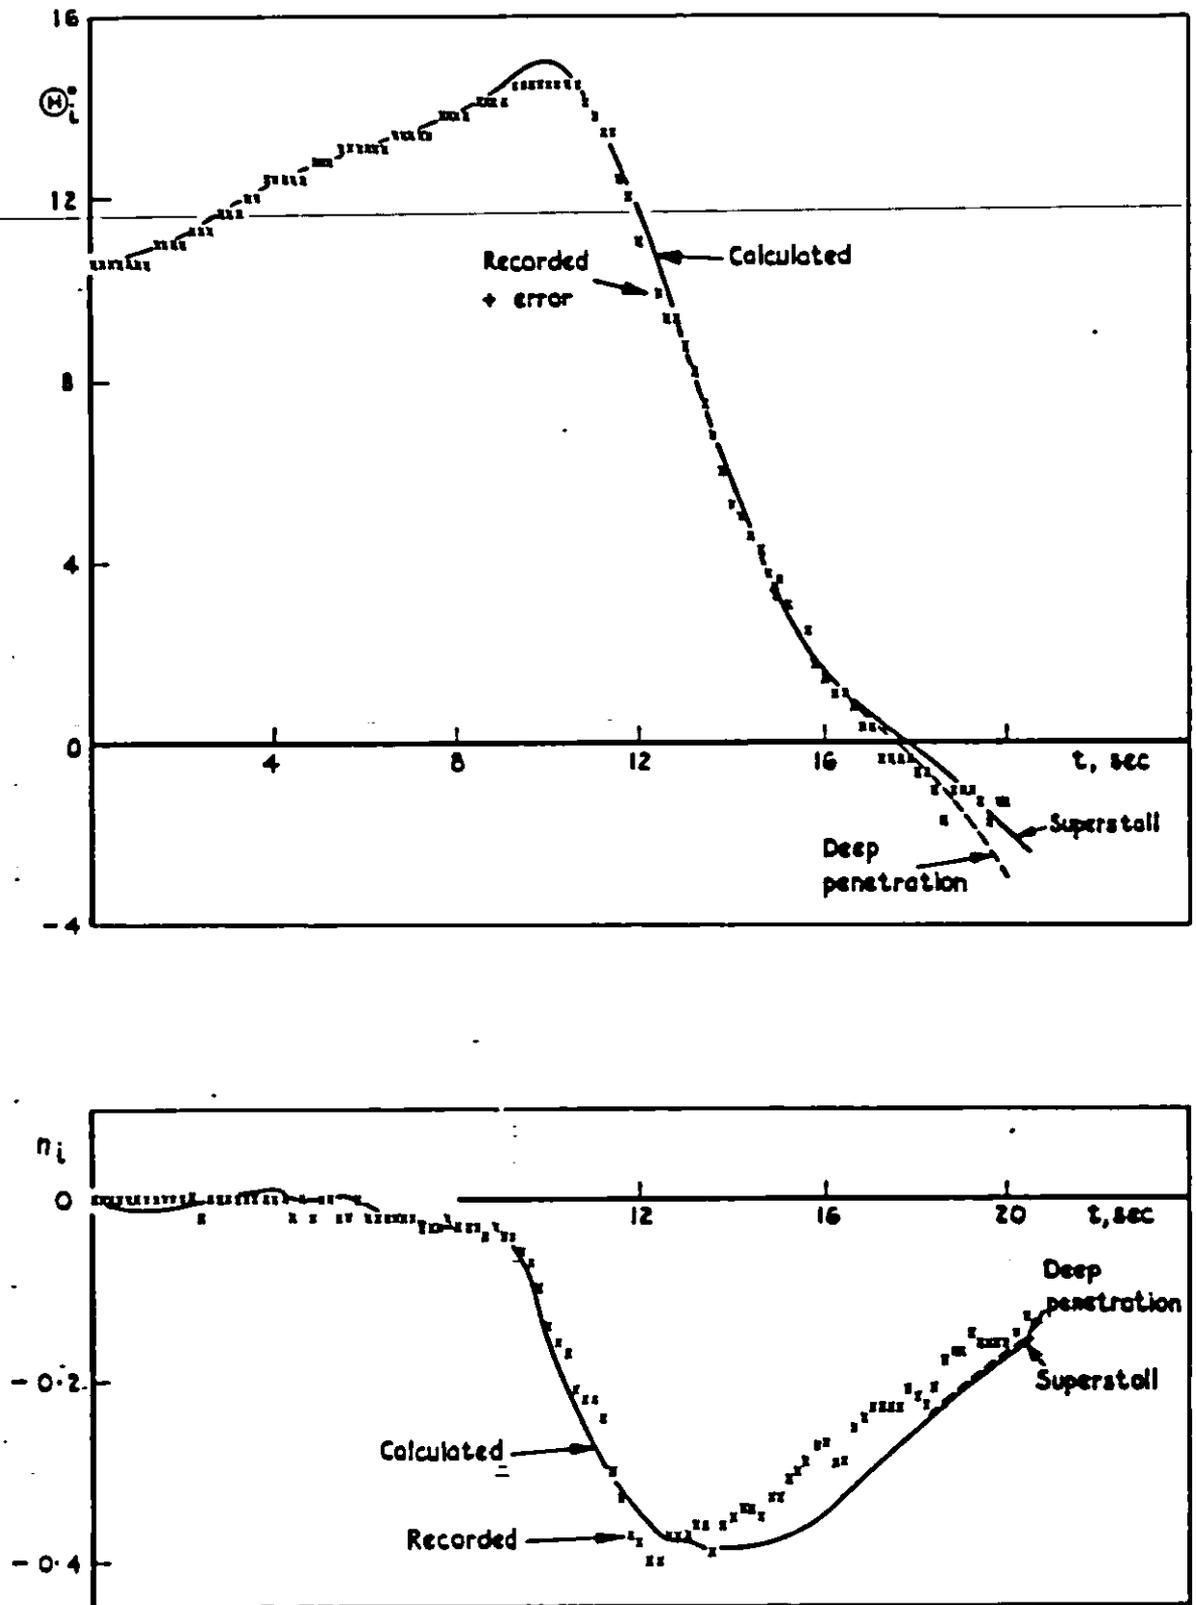
Fig.1 Pitch attitude (angle of inclination), H_i , and indicated normal acceleration factor

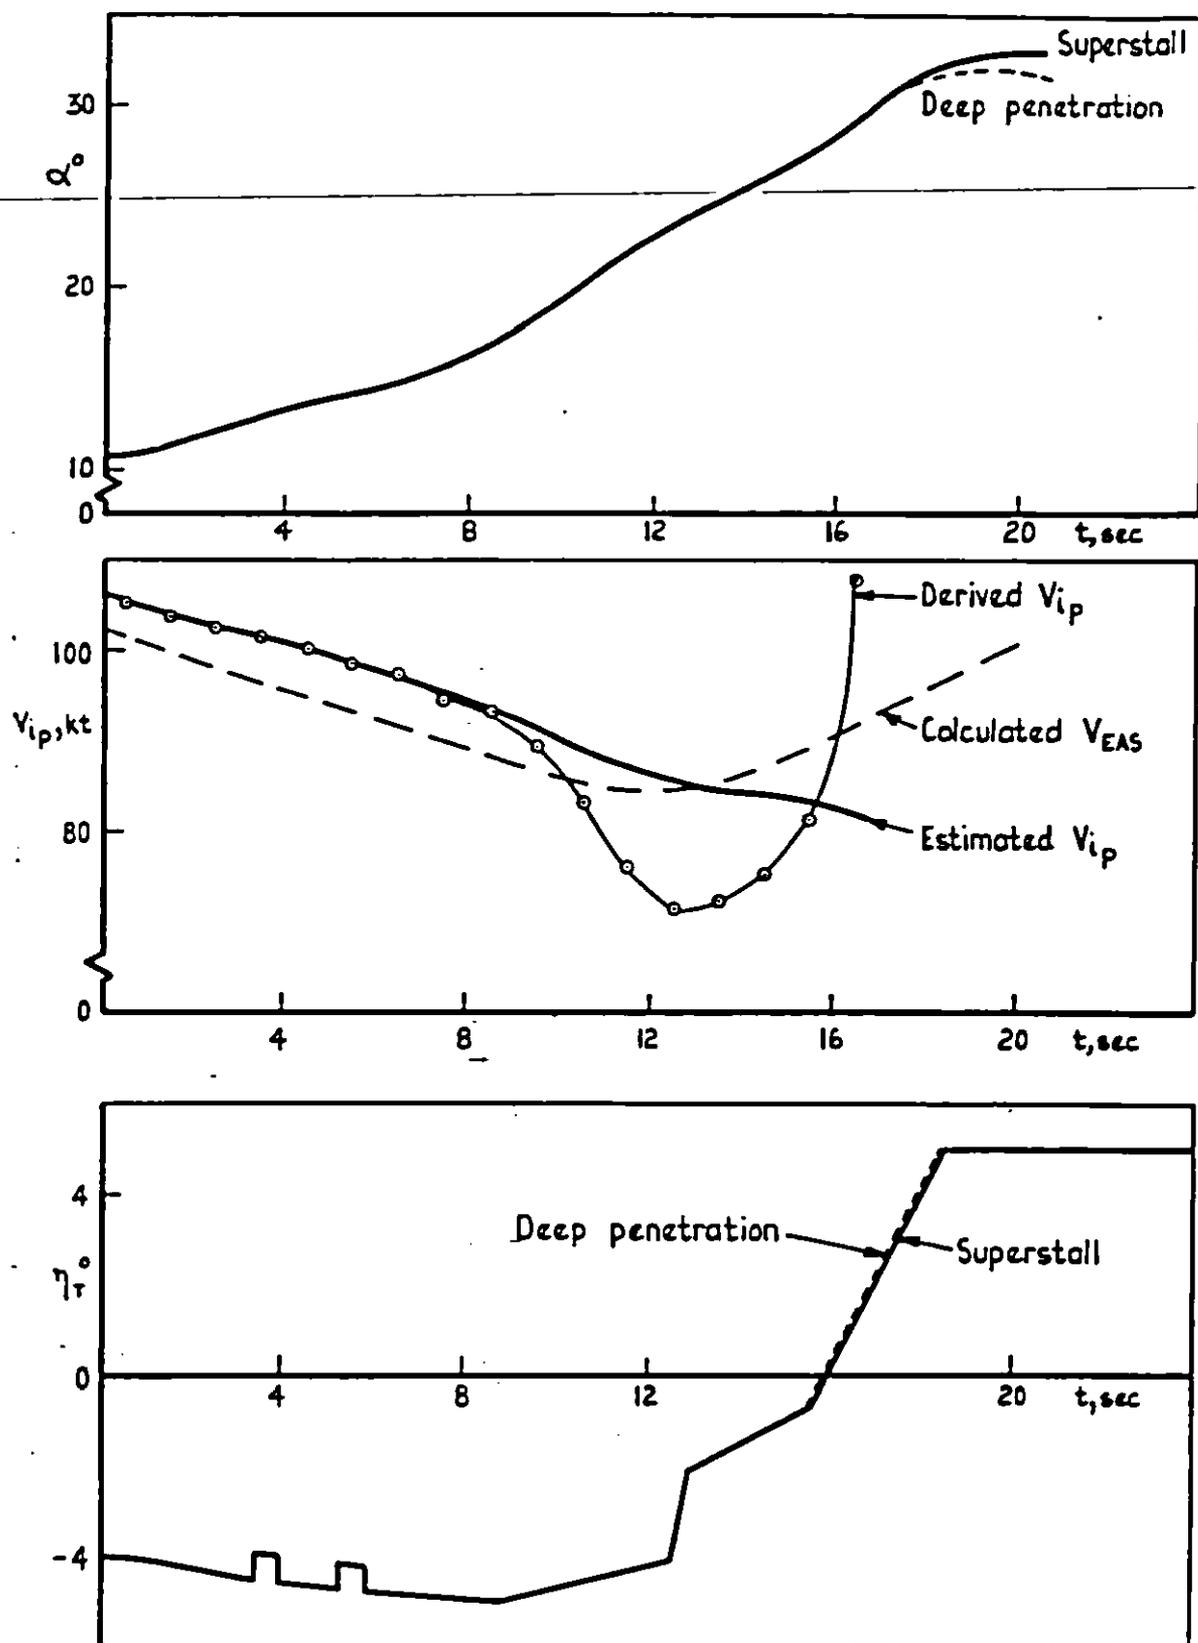
Fig. 3 Angle of incidence, α , velocity indicated to pilot, V_{ip} and tailplane angle, η_r

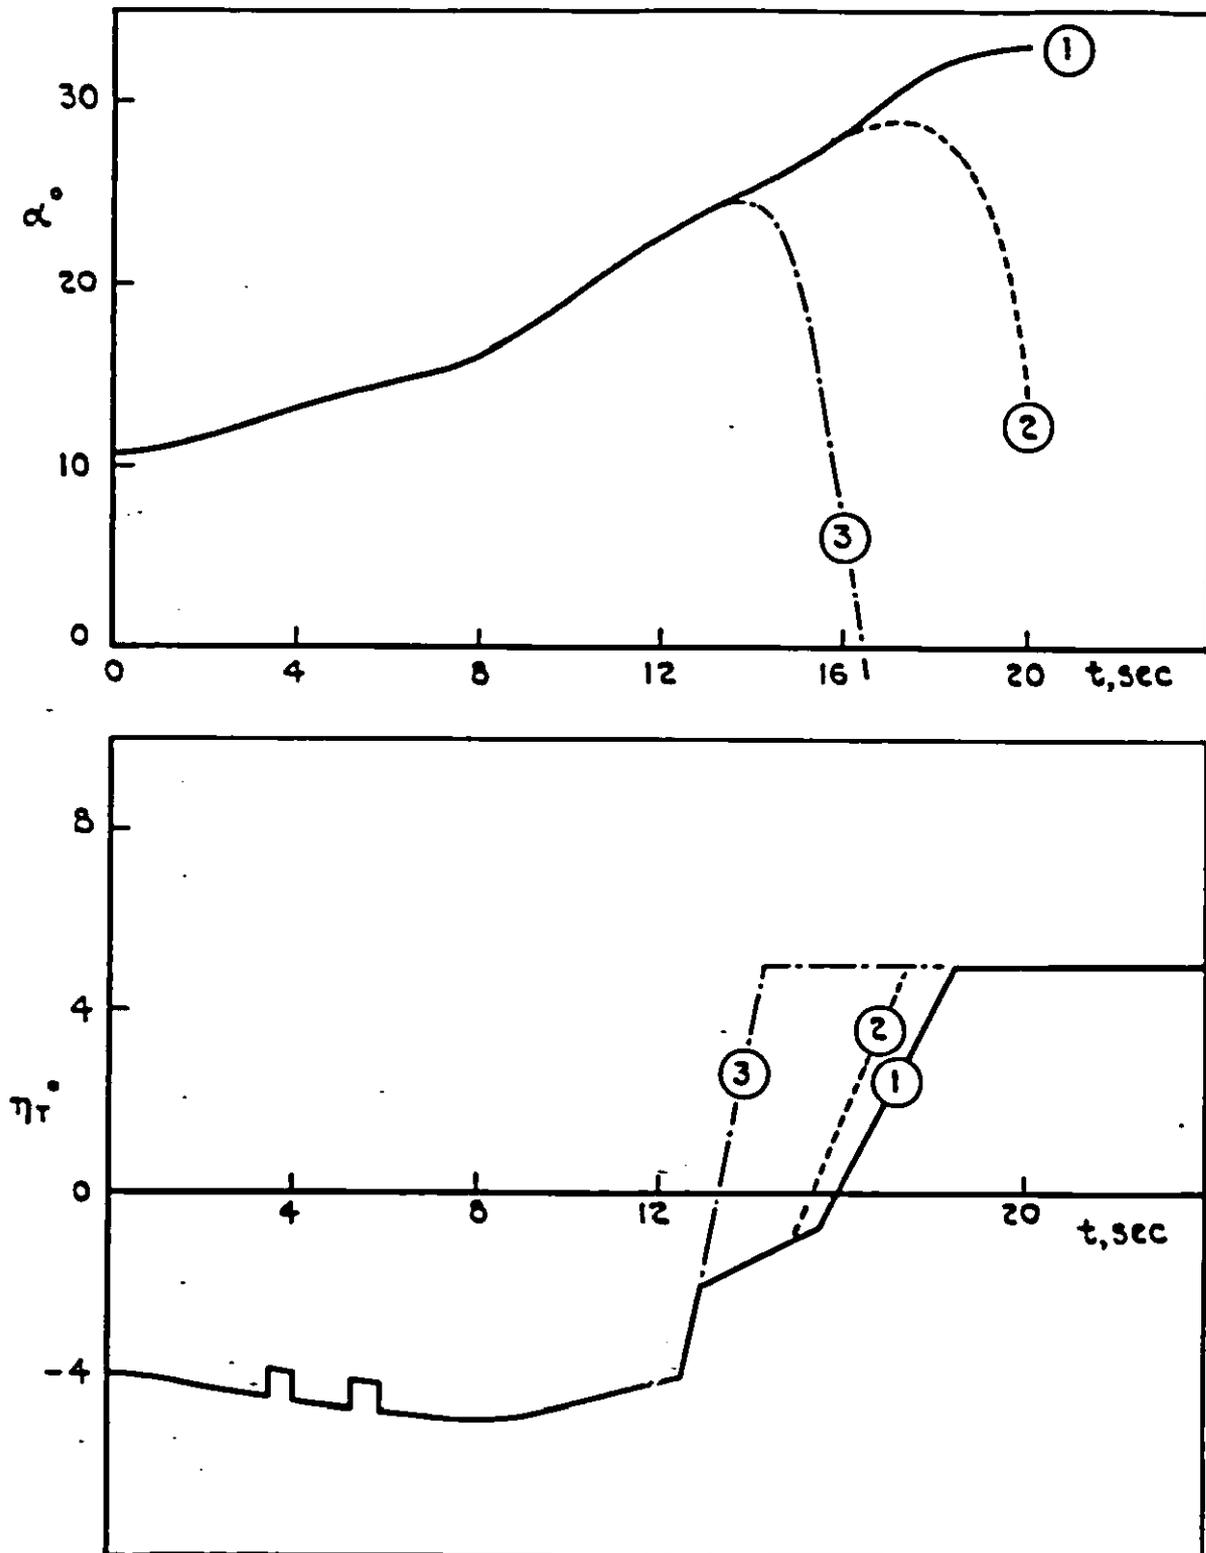
Fig. 4 Effect of different recovery action shown on the angle of attack, α

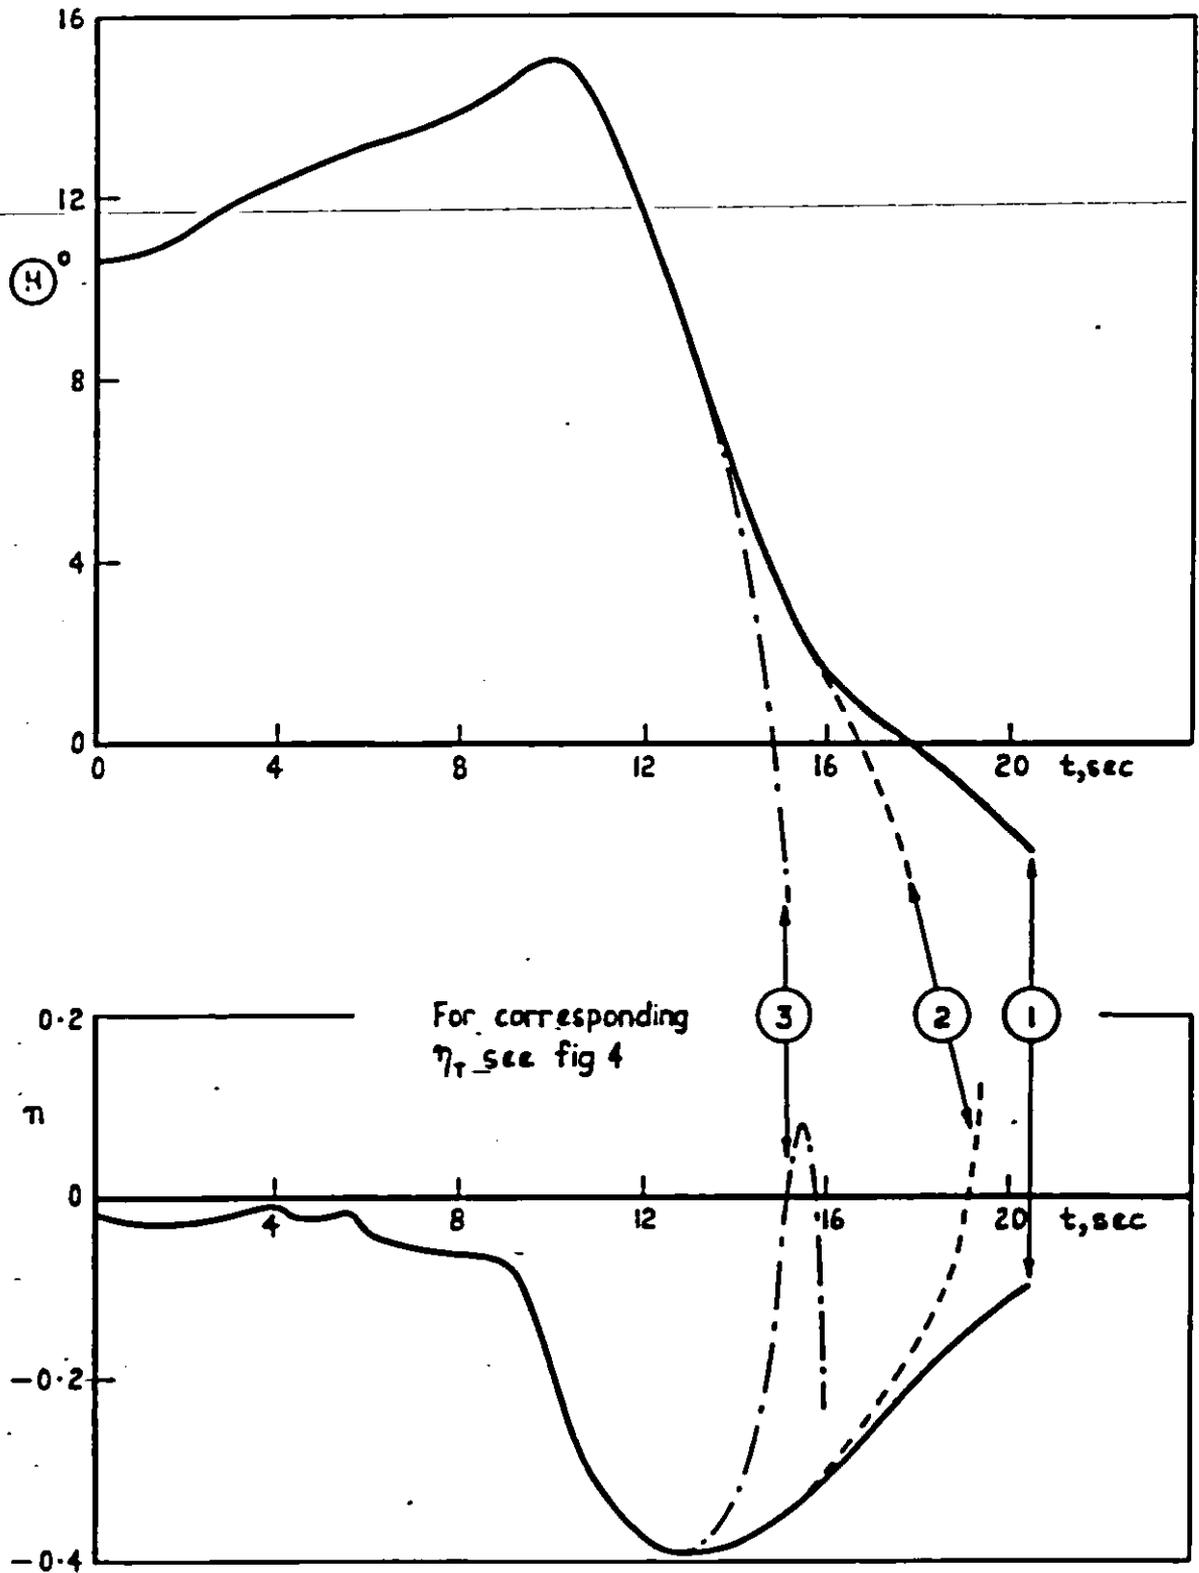
Fig. 5 Effect of different recovery action on pitch attitude (angle of inclination), H and on normal acceleration factor, n

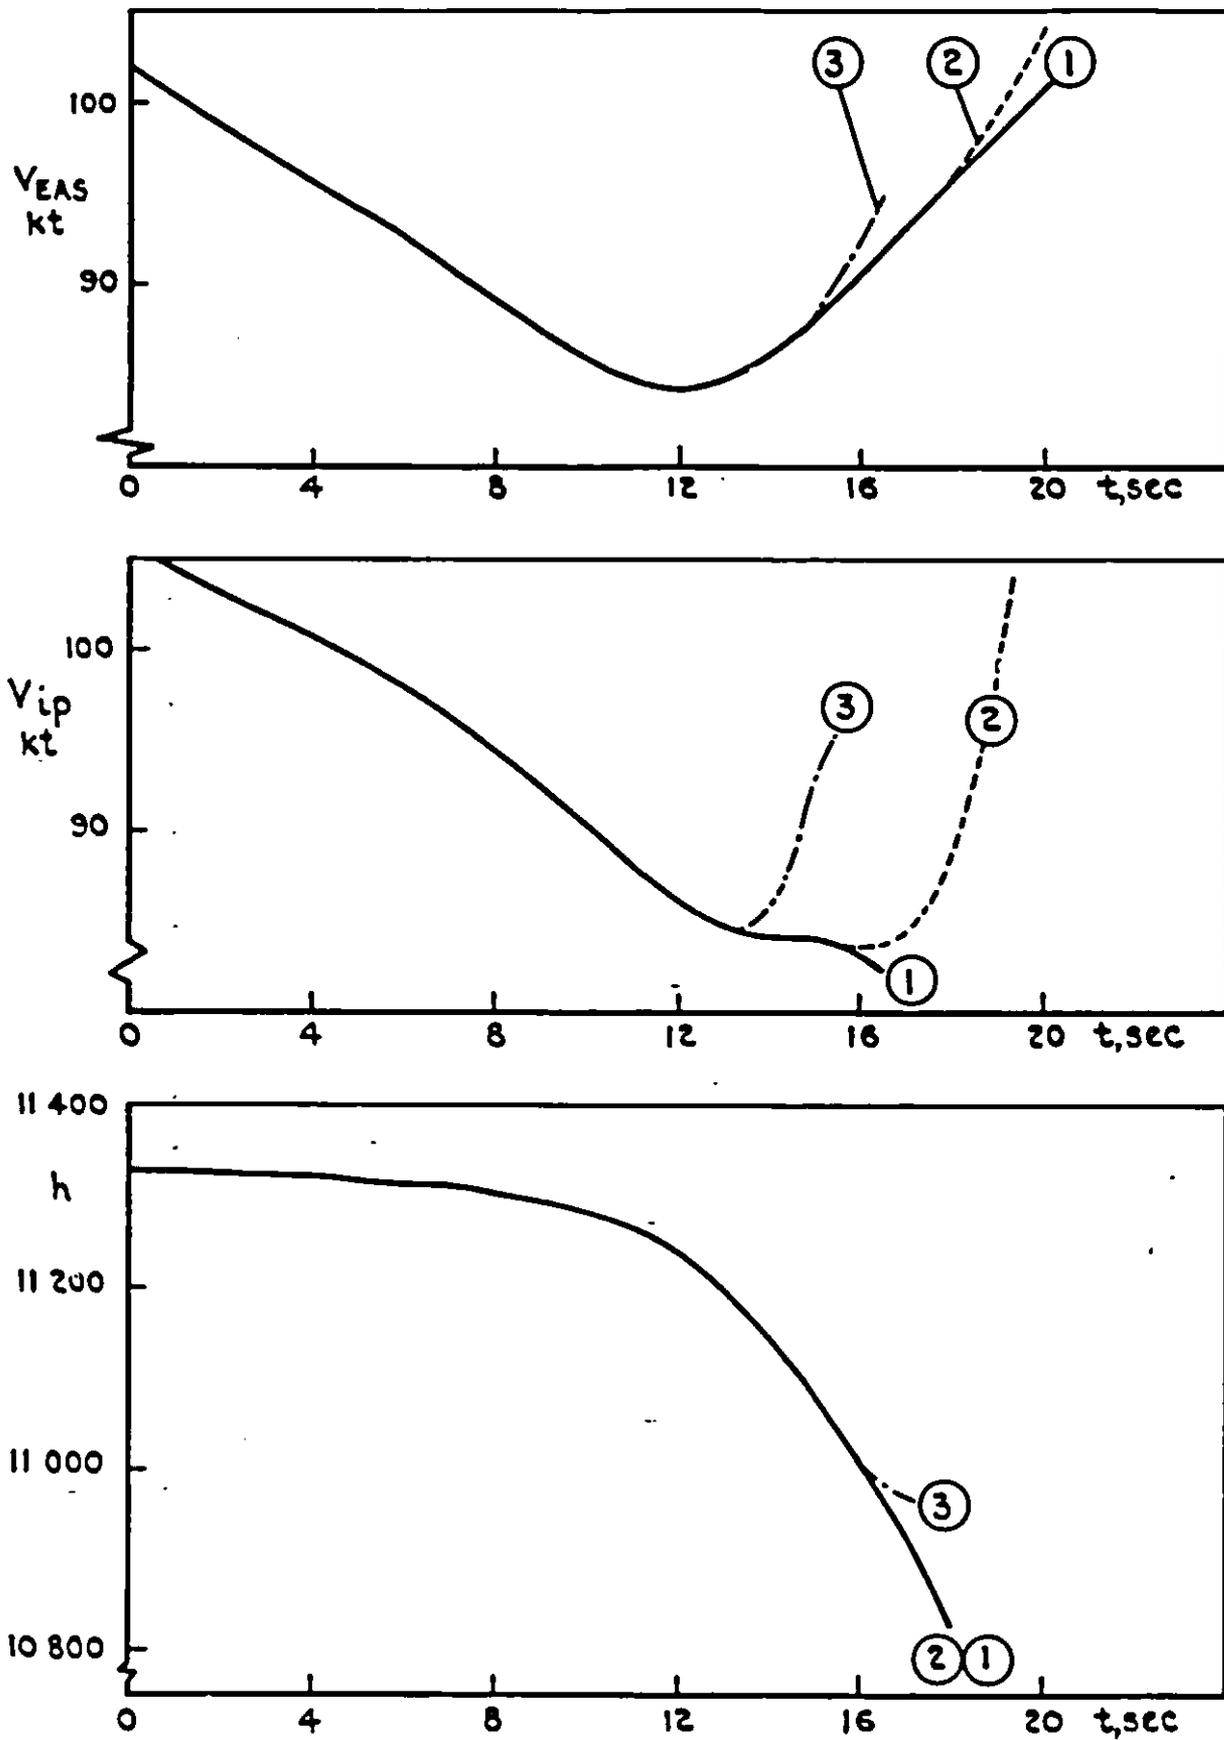
Fig. 6 Effect of different recovery action on airspeed (EAS & IAS) and height

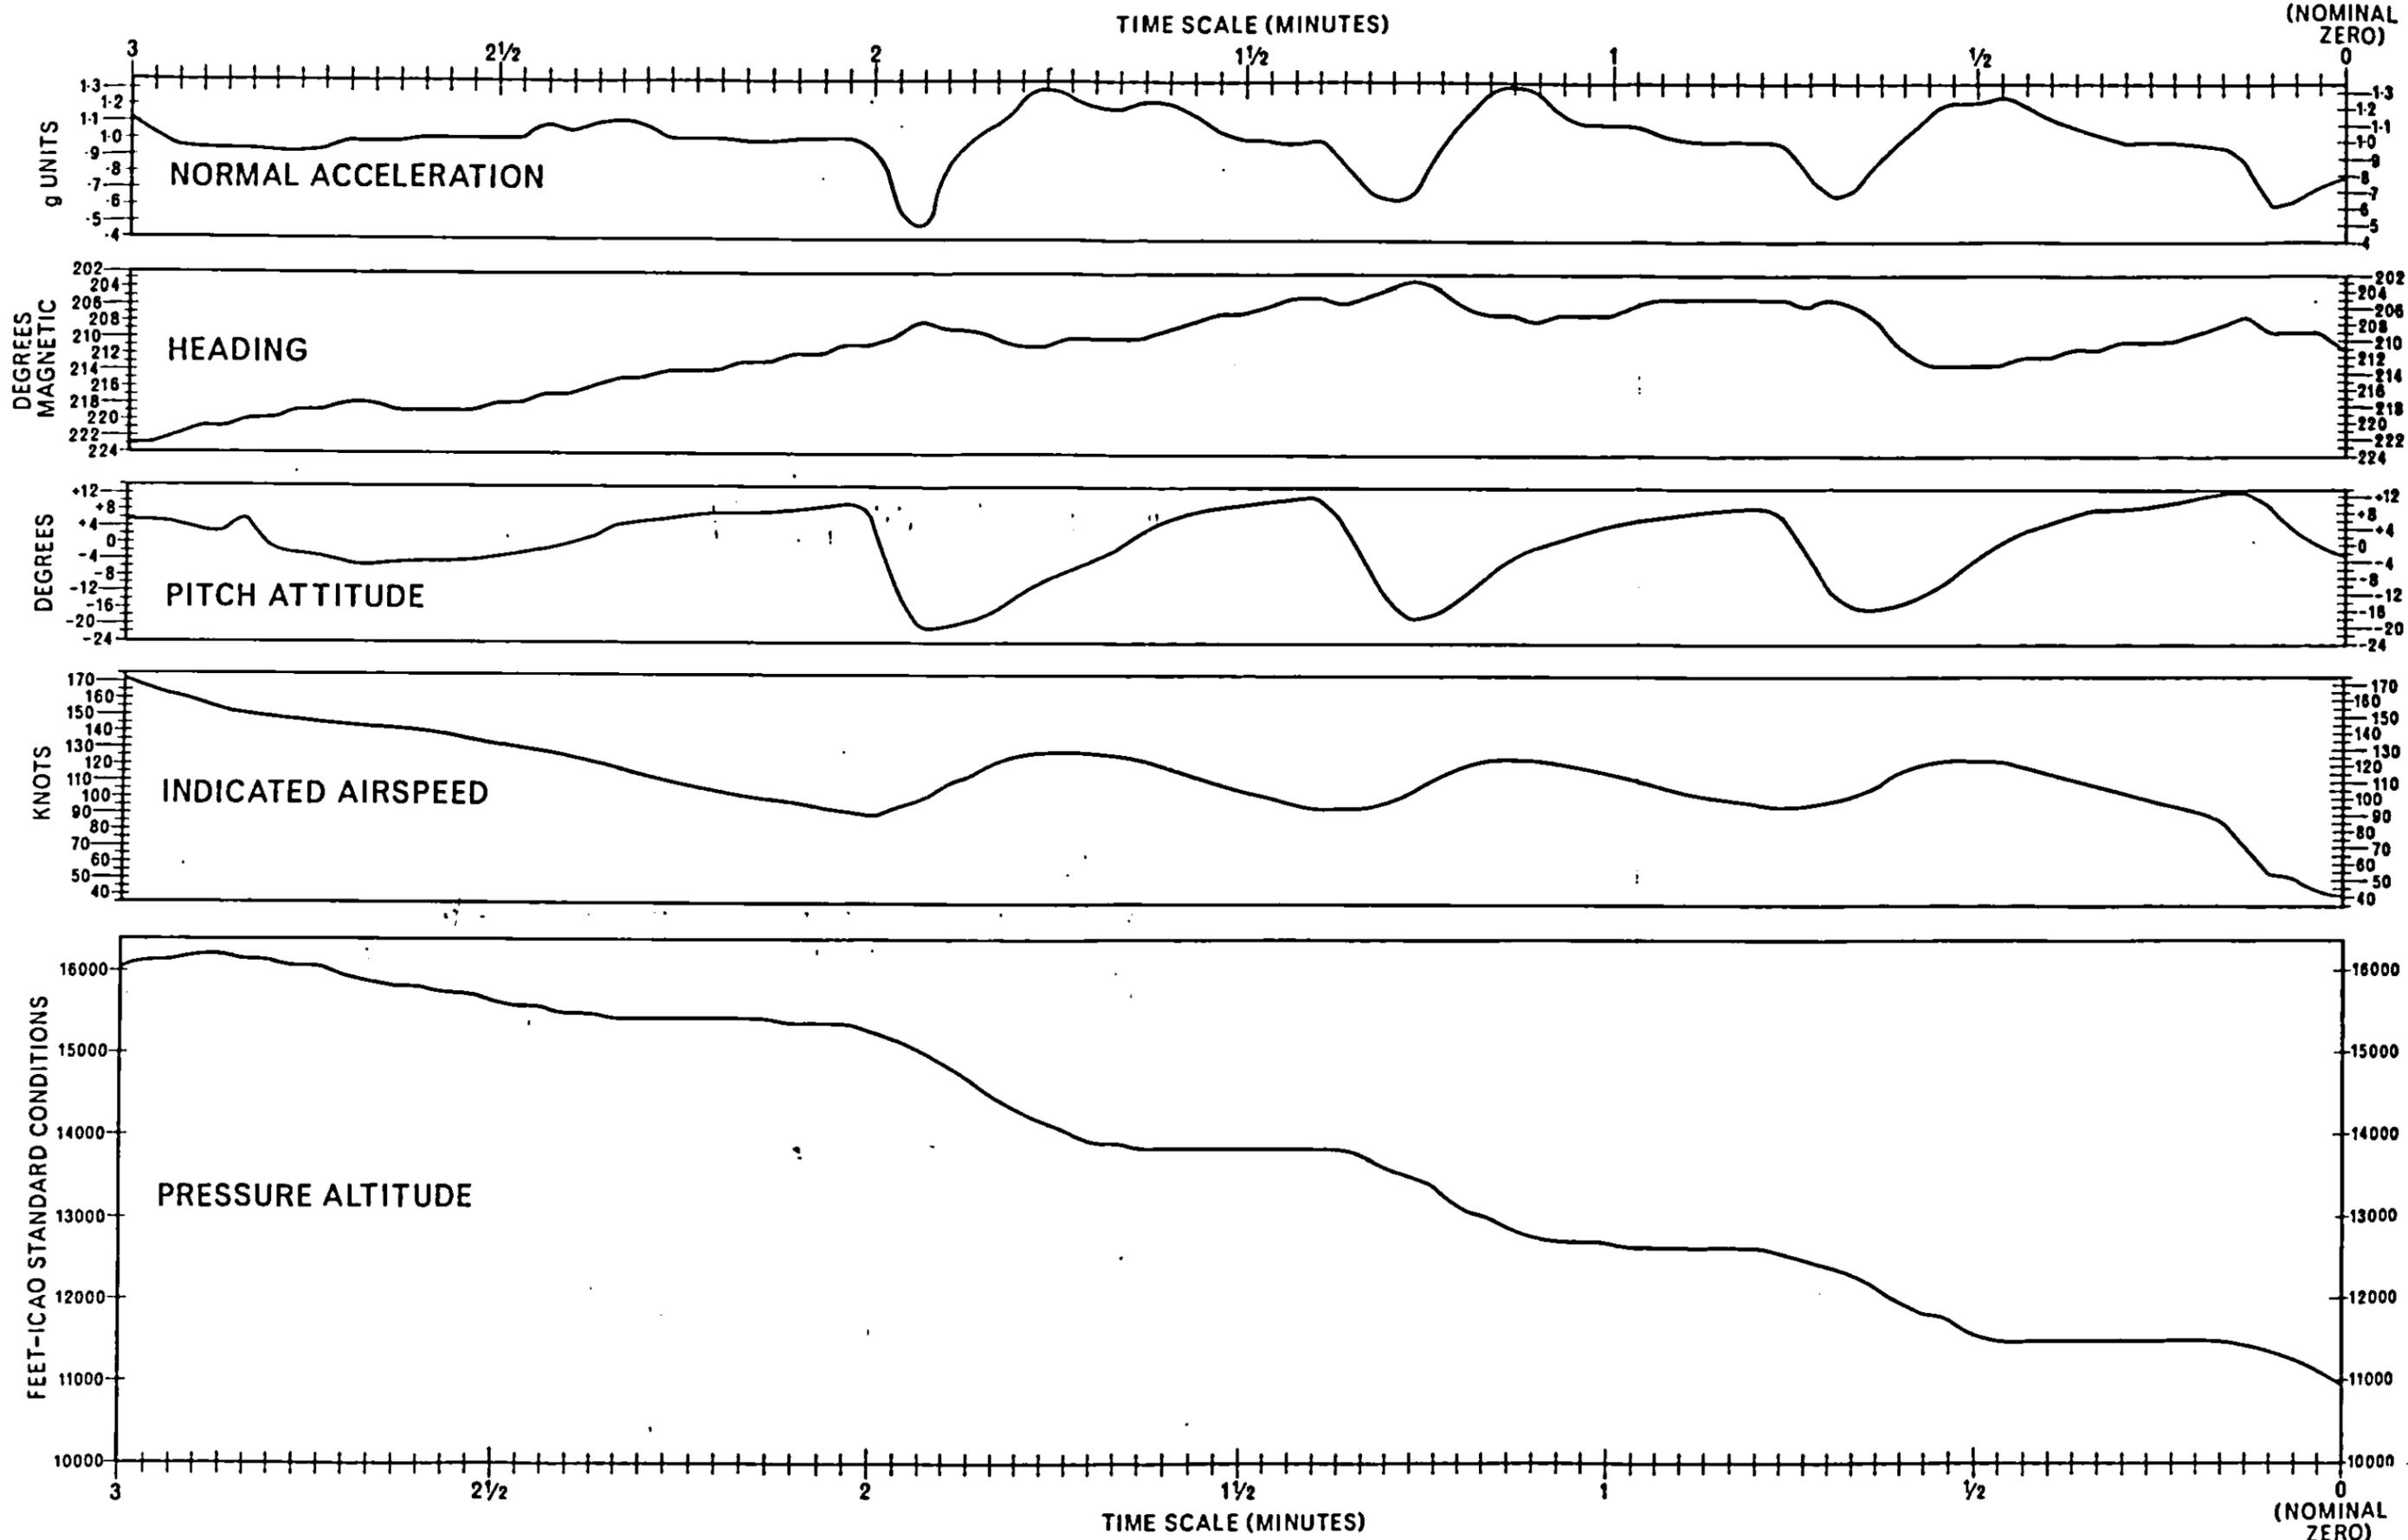
APPENDIX "A"
EW/C/0130

ACCIDENT TO TRIDENT I G-ARPY. 3RD. JUNE 1966

TIME HISTORY OF LAST 3 MINUTES OF FLIGHT RECORDER DATA
