# Berliner-Joyce XP-13 Viper

## The Boeing Model 299 Crash

### *"Cause of crash of the Boeing bomber"*

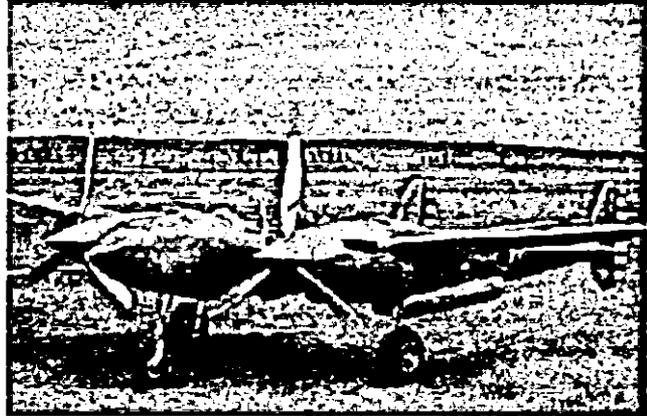
## Army's Fastest Plane Crashes

MITCHEL FIELD, N.Y., Feb. 11, 1939- The newest and fastest thing in fighting aircraft, Lockheed XP-38 the Army's twin-engined pursuit plane which took a year and a half to build, crashed today as it roared to a landing after a secret, record breaking speed flight across the continent. With Lieut. Ben S. Kelsey at the all-metal single-seater's controls, the "mystery" plane's tricycle undercarriage struck the top of a tree and crashed into a sand trap on a golf course adjacent to the Army airport. Kelsey was badly shaken but not seriously hurt. He was treated for a slight cut over the left eye and a scratch on one hand at the post hospital and then taken to post headquarters

where he told officers "I'm okay." The plane, which had reached speeds of almost 400 miles per hour in preliminary tests, left March Field, Cal., where its existence was divulged for the first time today., at 9:12 a.m., eastern standard time, and flew over Mitchel Field at 4:55 p.m., having stopped at Amarillo, Tex., and Dayton, O., for fuel. The elapsed time was 7 hours and 43 minutes, but the flying time, subtracting 21 minutes spent at Amarillo and 20 minutes at Dayton, was 7 hours and 2 minutes.

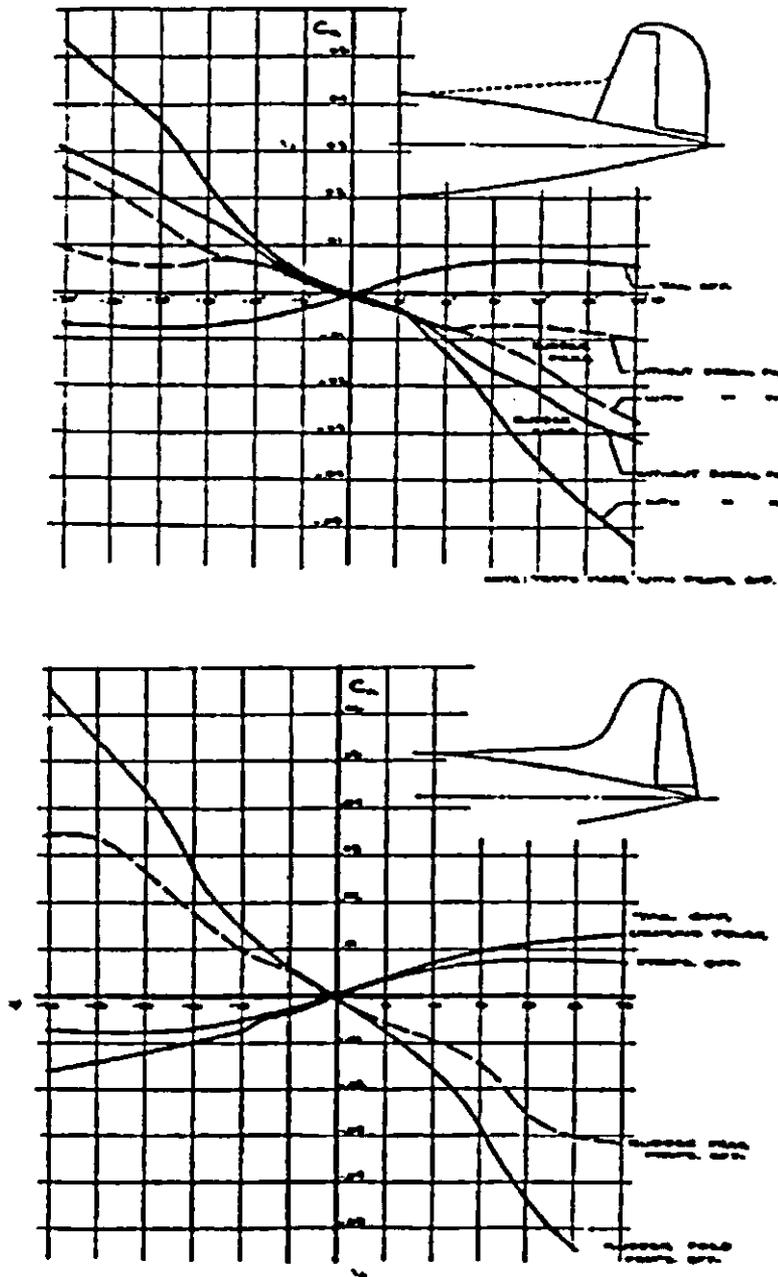
Figure 14.10 The variation of yawing moment coefficient with sideslip angle for the Boeing Stratoliner with original vertical tail (*above*) and revised vertical tail and dorsal fin (*below*). Rudder-free cases are shown by the dashed lines. With the original tail, adverse yawing moment due to the ailerons overcomes the low level of restoring moment at large sideslip angles, and rudder lock occurs. (From Schairer, *Jour. of the Aero. Sci.*, 1941.)
