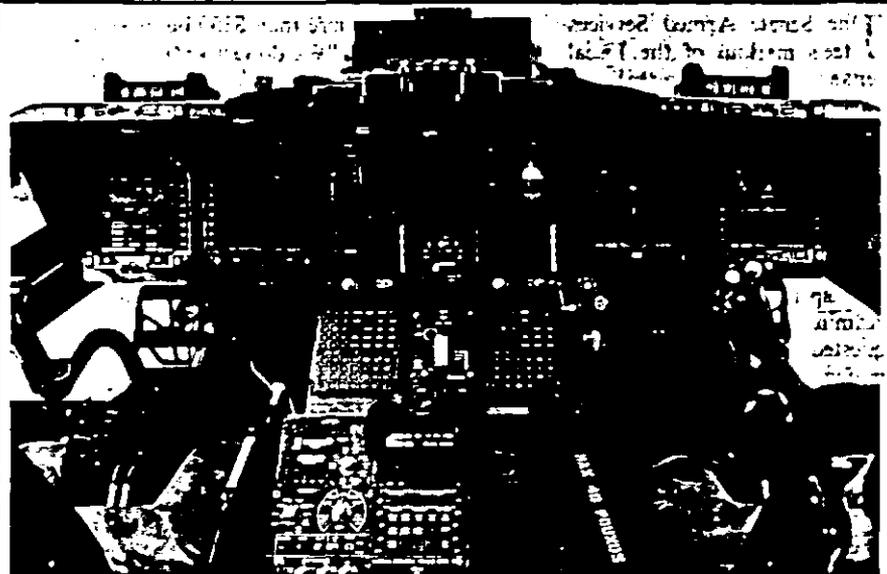
Cockpit of Bell/Boeing V-22 tilt-rotor aircraft has aircraft-type power lever immediately right of central console (identified by black and yellow striped circle), rather than a collective control.

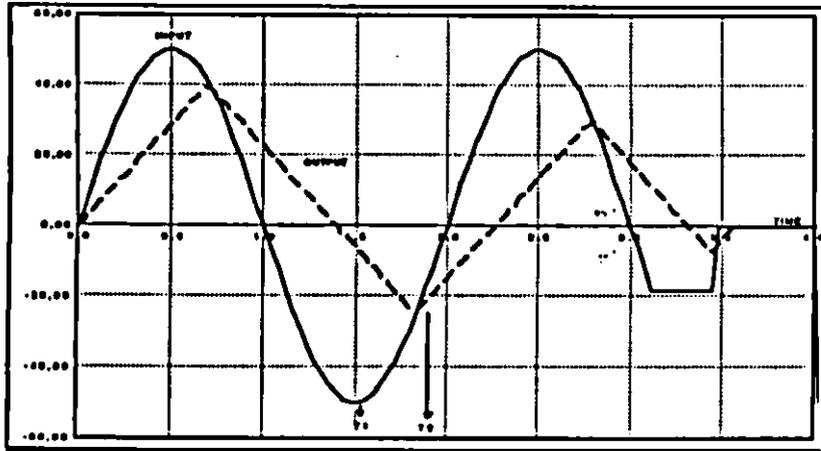
Figure 1. Effects of rate limiting.

Figure 1 illustrates the effect of rate limiting. As can be seen the input rate exceeds the output rate. The output moves as fast as it can until it reaches the commanded amplitude, then reverses direction and moves as fast as possible in the new direction. Note that the peaks in the output ( $T_2$ ) occurs later than those of the input ( $T_1$ ). This illustrates how rate limiting will cause time delays or phase lag. It's essentially this time delay that starts and maintains the PIO. Eventually the time delays will become so large that the artificial stability of a pitch unstable aircraft will be lost.

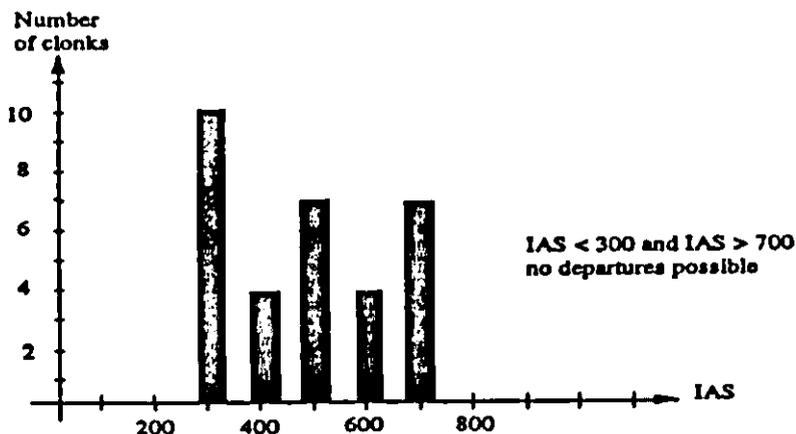
Figure 2. Number of "clonks" to departure as a function of IAS (km/h).

As indicated in figure 2 the aircraft was as most sensitive to large control inputs at 400 km/h and 600 km/h. The reasons for this is illustrated in figure 3 where forward path gain is plotted versus IAS. As can be seen maximum pilot command gain is available at these speeds.

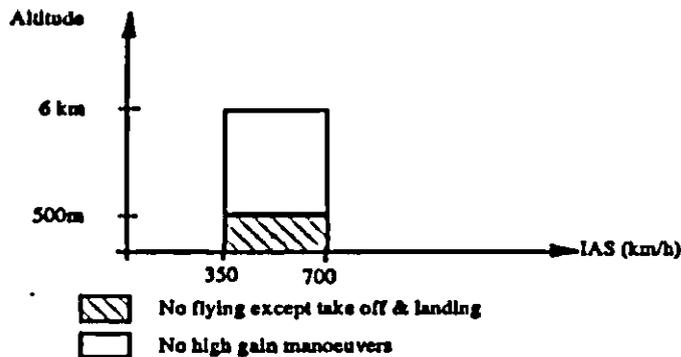
Figure 4. The flight envelope with the short term fix.

The critical envelope was divided into two segments. One segment was, at low altitude, where we could not rule out PIO triggers such as sudden encounters with birds. In this segment no flying would be allowed except for takeoff and landing. Within the rest of the critical envelope it was decided that no maneuvers that could trigger a PIO, such as formation flight, were to be performed. Outside these two segments the airplane could be flown "as usual".

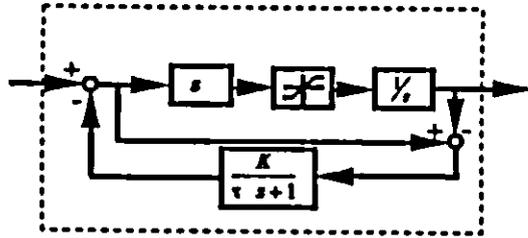
Figure 7 illustrates the RLIMFB filter. With no rate limiting present the feedback loop is not active. In a rate limit situation however the difference between input and output signal is subtracted from the input signal. This feedback reduces the input so that, in a limitation case, when input reverses, the output follows with just a slight delay. The filter has soft behavior and minor trim offset and other properties can be adjusted by filter parameters.

The RLIMFB filter is a fairly simple control system block with no switching logic. Filters designed using switching logic can have fairly good characteristics but tend to be complicated. The RLIMFB filter is designed as illustrated in figure 7. The diagram shows that the output signal changes sign as desired, just slightly delayed, and there is no mistrim present when the input signal goes to zero.

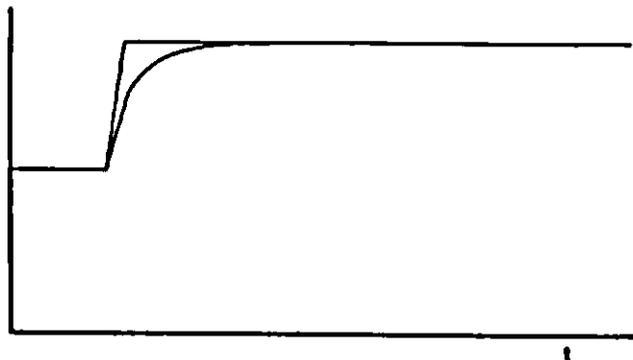
Figure 8. "Drool" for step input in the Saab RLIMFB filter design

Extensive analytic design work as well as simulator trials have been performed in order to optimize the filter parameters. You seldom gets something for free - the price although small, was a "drool" experienced for step inputs during pilot in the loop simulations see figure 8.

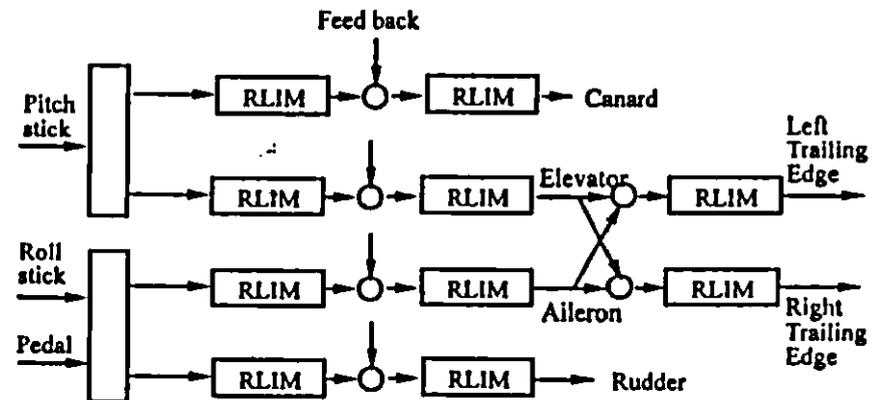
Figure 9. RLIMFB filter location in the Gripen EFCS.

The "drool" effect found in the simulator has proven not to affect the HQ during real flying. This is likely due to the fact that square type inputs are softened by lag lead filters in the forward loop and that several RLIMFB filters are interacting in the system. As seen in figure 9 RLIMFB filters are present at several places in the forward and feedback loops.

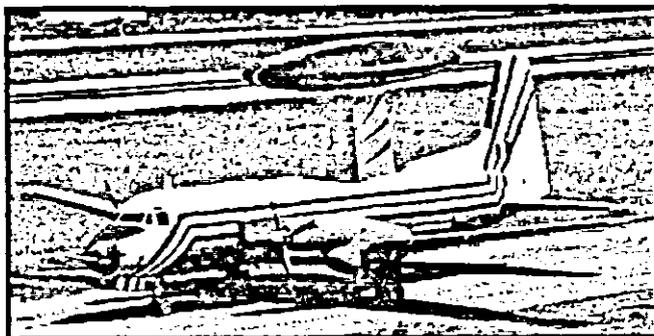
The HS-748 Avro based Flying Chapatti

Speculation was rife about possible causes of the crash. One theory based on eyewitness accounts suggested that the rotodome may have collapsed, causing the pilot to lose rudder control. CABS scientists however found it hard to believe the rotodome collapsed on the plane. The indigenous fabrication of the rotodome mounting had won the team the DRDO's "outstanding contribution award" in 1992, and no problem had been reported in nine years.

Indian Air Force(IAF) pilots pointed out that though old, the Avro's were not unsafe. The IAF was in fact still flying a couple of dozen of these aircraft. The IAF which lost four of its men in the accident commissioned a four-member team to look into it. The blackbox, containing critical records of the last hour of the flight were recovered and studied. Meanwhile the ASP programme was grounded until the real reason of the crash could be determined. Investigations into the crash later revealed that the rotodome fitted on the Avro had indeed broken off, hit the aircraft's tail and resulted in the accident.

The HAL-748 plane crashed 2,5km from the Arakkonam NAS. The aircraft crashed in a dense forest. The HAL-748 was converted to carry a rotordome, which would ultimately house the in-built radar, on top. Preliminary reports suggest the dome collapsed on top of the aircraft, since the dome was found 2km from the runway.
