BAC 1-11

"Deep Stall"

British Ministry of Aviation Accident Report:

Stable Stall Ruled BAC 111 Crash Cause

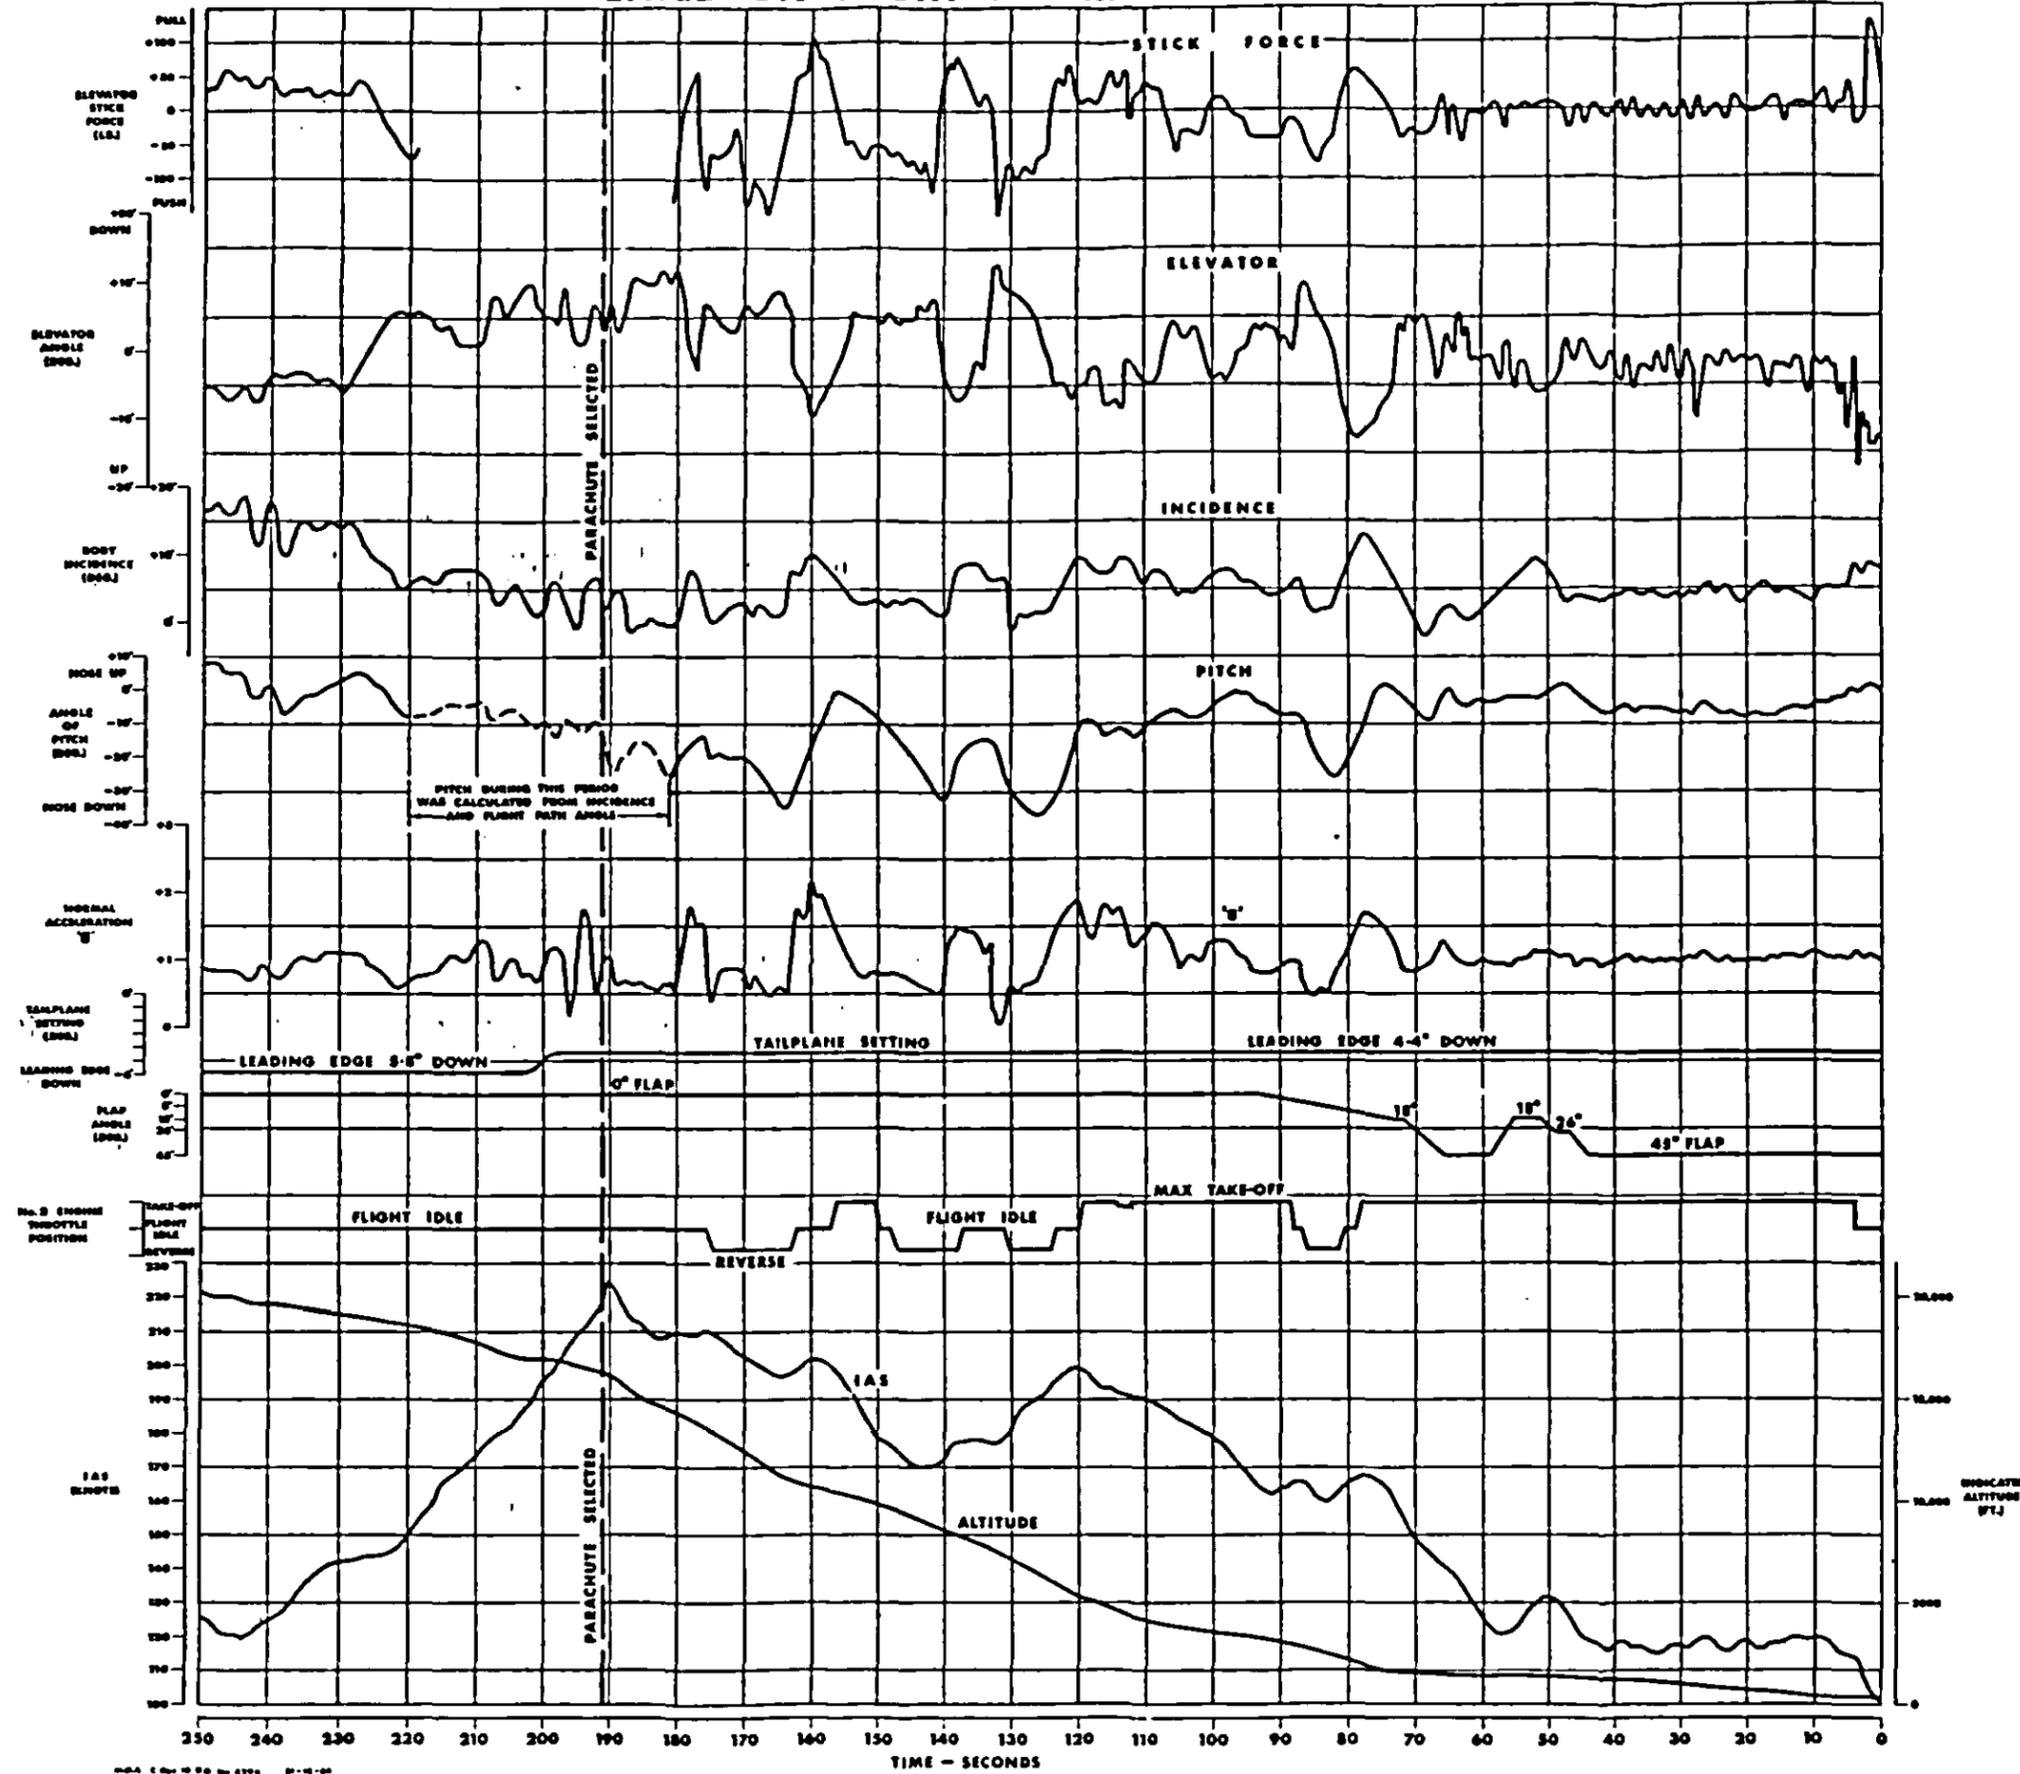
TIME HISTORY FOR THE 250 SECONDS BEFORE TOUCHDOWN BASED ON FLIGHT RECORDER DATA

However, the movement of rudder and ailerons is not inconsistent with an attempt by the pilot to regain control by putting the aircraft into an appreciable asymmetric flight condition. At impact minus 50 sec., when the pitch angle was 4 deg. nose-down, full power was applied from both engines and maintained for about 15 sec. This application of power was accompanied by a rapid pitch-up reaching 17 deg. nose-up; power was then reduced by the pilot apparently to prevent continuation of the pitch-up.

Whilst there is some lack of evidence on the pilot's intentions in this stalling test, the traces, taken in conjunction with Mr. Lithgow's remark after the previous stalling tests that it should be possible to fight one's way through the wing drop, are not inconsistent with an attempt to reach a stall as defined by the British Civil Airworthiness Requirements. As a result, the aircraft penetrated further into the post-stall region than it had been taken previously and reached the stable stalled condition from which recovery was not possible.

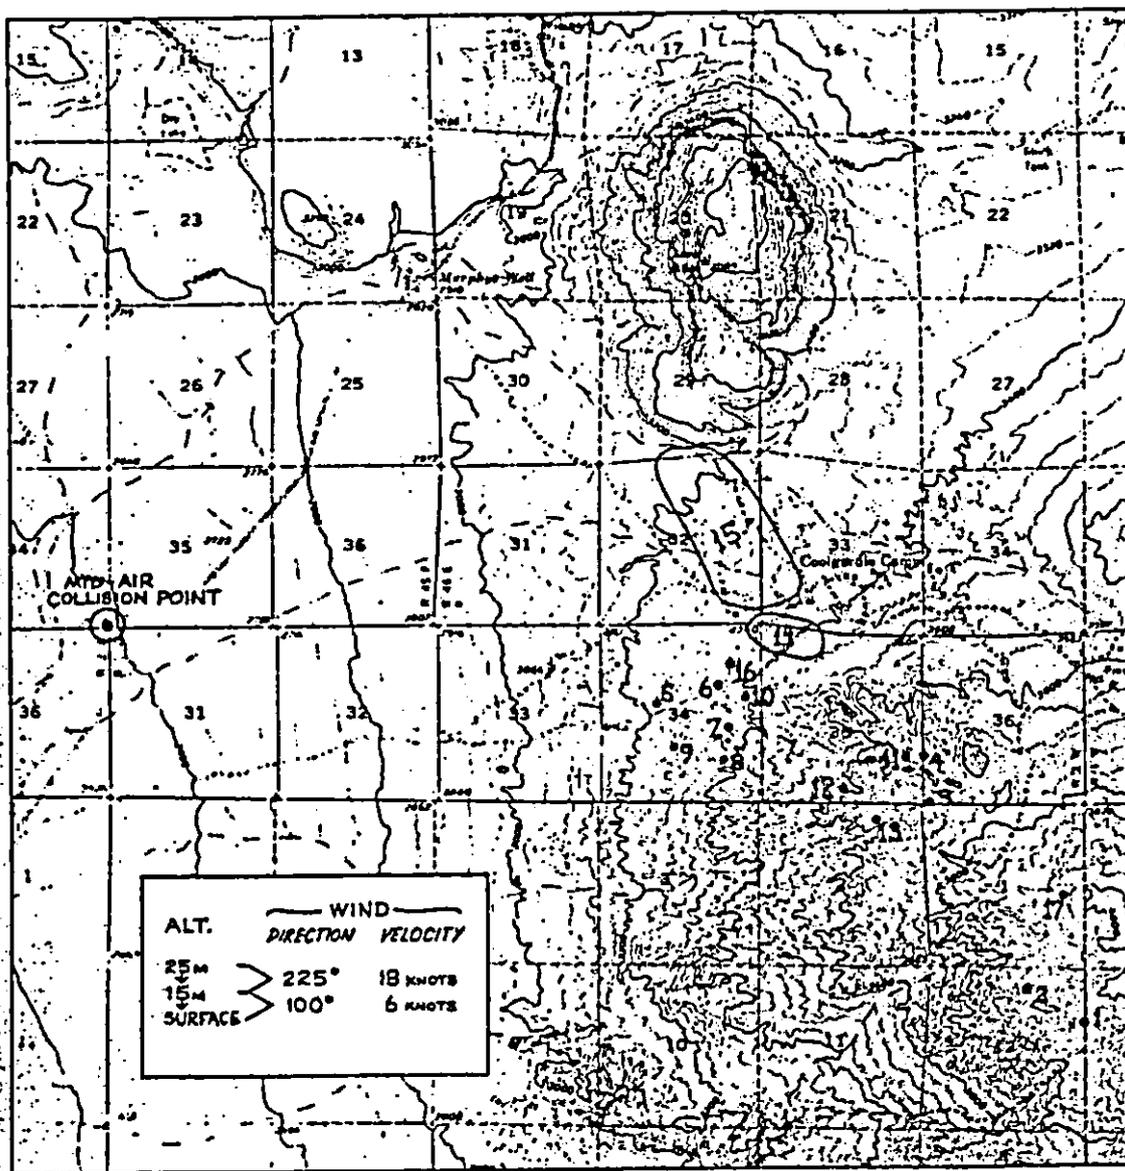
1. B-70 Main Impact Area
2. B-70 Left Wing Section
3. F-104 Fuselage and Engine
4. F-104 Cockpit Section
5. B-70 Left Rudder Section
6. F-104 Tail Section
7. F-104 Left Tip Tank, aft section
8. F-104 Fuselage Tanks
9. F-104 Right Tip Tank
10. F-104 Right Wing Outboard Section
11. F-104 Air Conditioning Package
12. F-104 Fuselage Nose Cone
13. F-104 Nose Gear
14. Area Containing - B-70 Right Rudder Tip
B-70 Rudder Structure
F-104 Fuselage, E-Bay Sect.
F-104 Fuselage Skin Structure
F-104 Misc. Fuselage Structure and
Components
15. Area Containing - B-70 Rudder Structure and
Misc. B-70 Pieces
F-104 Fuse Structure and
Misc. F-104 Pieces
including F-104 Outboard left Stabilizer tip.
16. F-104 Pilot's Helmet
17. B-70 Pilot Capsule
